Manhole Inspection Summary

Manhole # S47C__043MH

Insp Date: **7/14/08 11:49 AM**

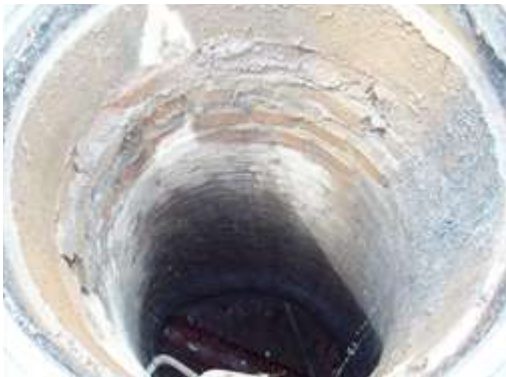
Defect 2

Infiltration: ☐ None ☐ Joint ☐ Cracks ☐ Mortar ☐ Roots ☒ **Wall**

infiltration

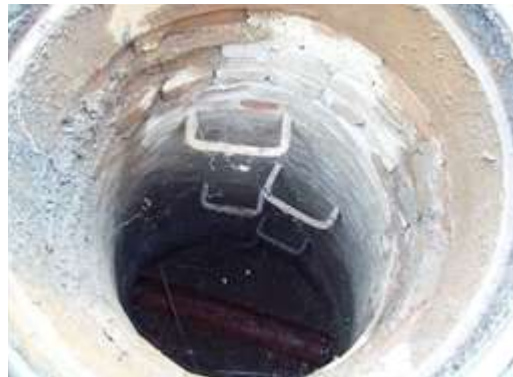
Defect 1

Condition: ☐ Sound ☐ Cracked ☐ Root Intrusion ☒ **Loose Brick** ☐ Deteriorated

Infiltration: ☐ None ☐ Joint ☐ Cracks ☒ **Mortar** ☐ Roots ☐ Wall

loose brick

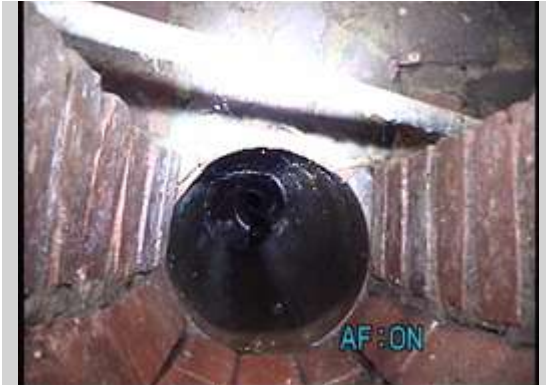
12 O'Clock Outflow

8 in. Circular Gravity Sewer
Pipe Out @ 12 O'Clock

Pipe Height: **8.4** (in.) Rod and Bar (Angled)
Pipe Material: **Clay** ☐ Pipe Lined
Invert Depth: **10.80** (ft.) Flow Characteristics: **Fast**
Deposits: ☒ None ☐ Mud ☐ Sludge ☐ Debris ☐ Grease
Silt Depth: (in.) Deposits Extent:
Infiltration: **None** Pipe Seal Cond: **Sound**

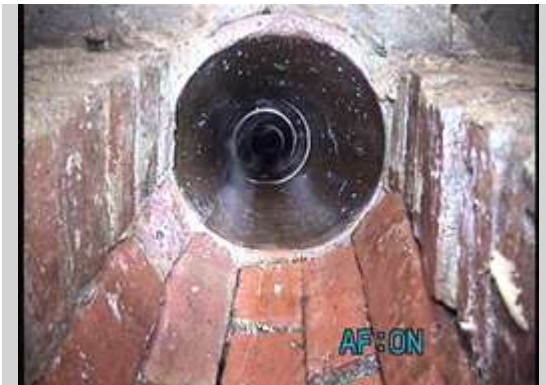
6 O'Clock Inflow

8 in. Circular Gravity Sewer
Pipe In @ 6 O'Clock

Pipe Height: **8.4** (in.) Rod and Bar (Angled)
Pipe Material: **Clay** ☐ Pipe Lined
Invert Depth: **10.20** (ft.) Flow Characteristics: **Fast**
Deposits: ☒ None ☐ Mud ☐ Sludge ☐ Debris ☐ Grease
Silt Depth: (in.) Deposits Extent:
Infiltration: **None** Pipe Seal Cond: **Sound**
